NASA Contractor Report 174739

High Temperature Low-Cycle Fatigue Mechanisms in Single Crystals of
Nickel-Based Superalloy Mar-M 200

Walter W. Milligan and N. Jayaraman

University of Cincinnati
Cincinnati, Ohio

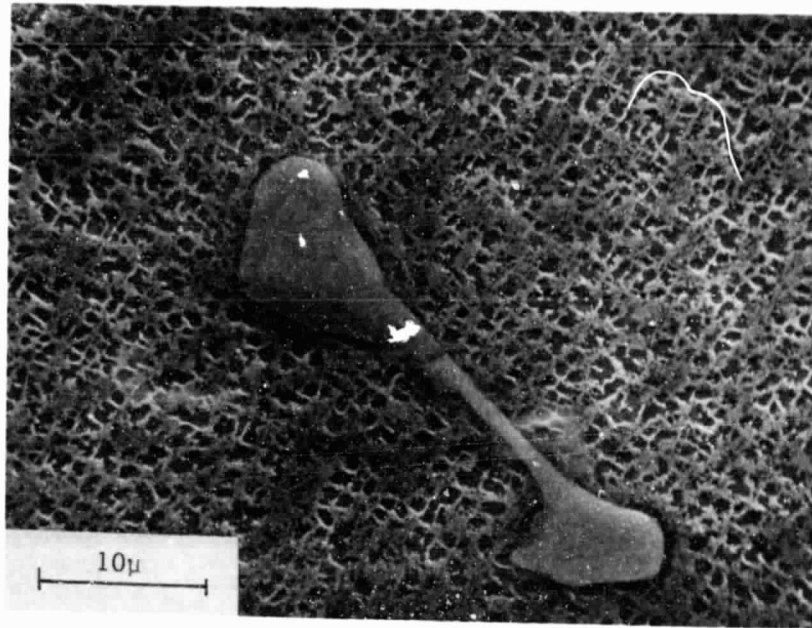
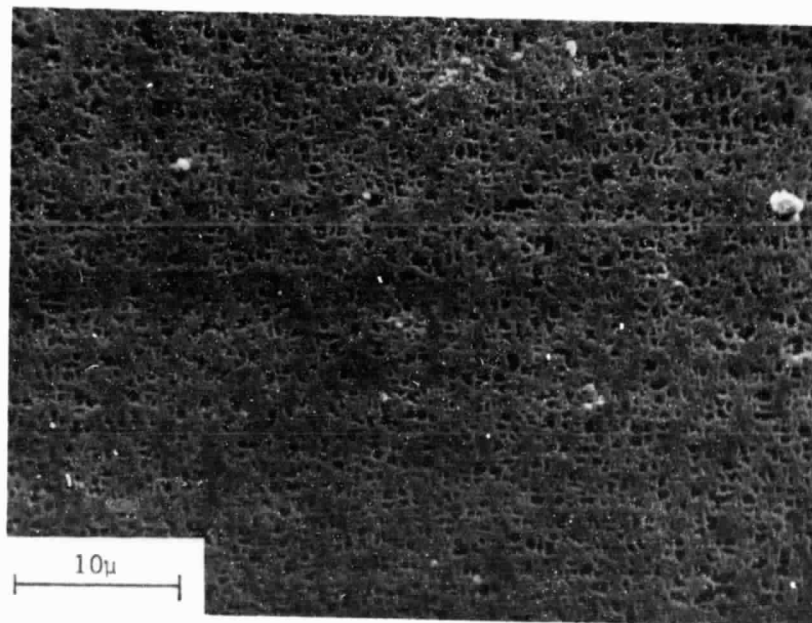
Fig. 2. SEM micrographs of the as-received microstructure. A) Interdendritic region, showing large, primary γ' and finer, secondary γ' , and an MC carbide. EDS analysis showed the carbide to be rich in W, Ti, and Cb. B) Dendrite core, showing smaller primary γ' size and a smaller volume fraction γ' .

The specimens were heat treated as follows: Solutionized at 1230°C for 4 hrs, argon quenched, and aged at 870°C for 32 hrs. The resulting microstructure (Figure 2) consisted of a duplex γ' structure containing large, primary γ' which was present from the melt, and finer, secondary γ' which was precipitated during heat treatment.

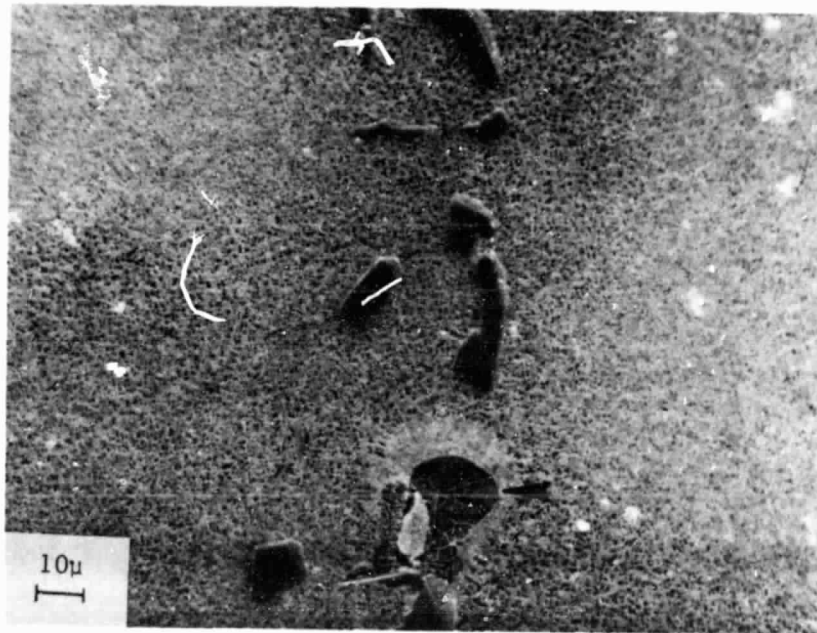
Fig. 3. Lower magnification SEM micrograph illustrating the dendritic segregation. Note the large, "patchy" γ' in the interdendritic region (arrow). Other large particles are MC carbides.

Due to slow solidification rates in the single crystal growth process, the structure was highly segregated (dendritic). (Figure 3). The dendrite cores (which are reported to be rich in W and Co) contained a smaller average γ' size, and a smaller volume fraction of γ' . The interdendritic areas (which are reported to be rich in Cr, Ti, Ni, and C) contained a larger average γ' size, as well as a larger volume fraction of γ' . (Figure 2). The interdendritic regions also contained MC carbides and "patchy" γ' .

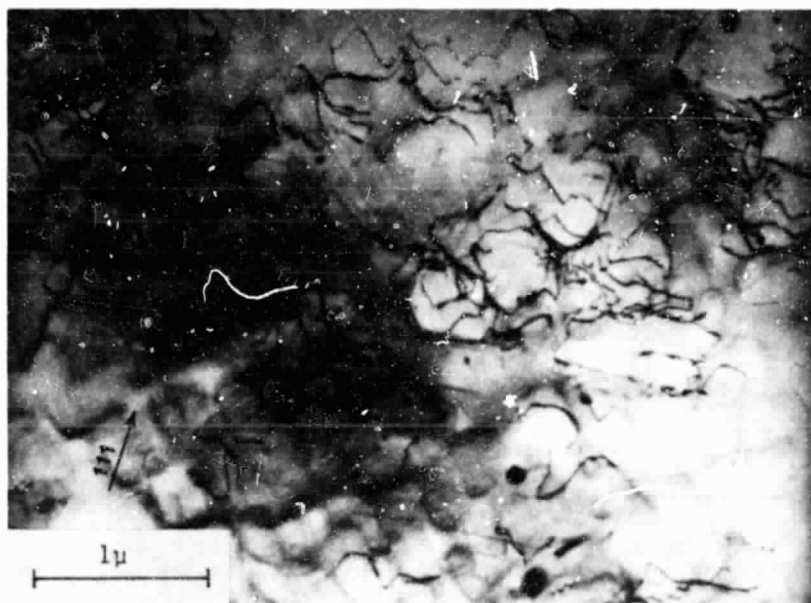
Fig. 4. Bright field (BF) TEM micrograph of the as-received microstructure. Note the interfacial dislocation network and carbides (small dark particles).

at the γ/γ' interface, as well as sub-microscopic carbides in the interdendritic regions. (Figures 4,5).

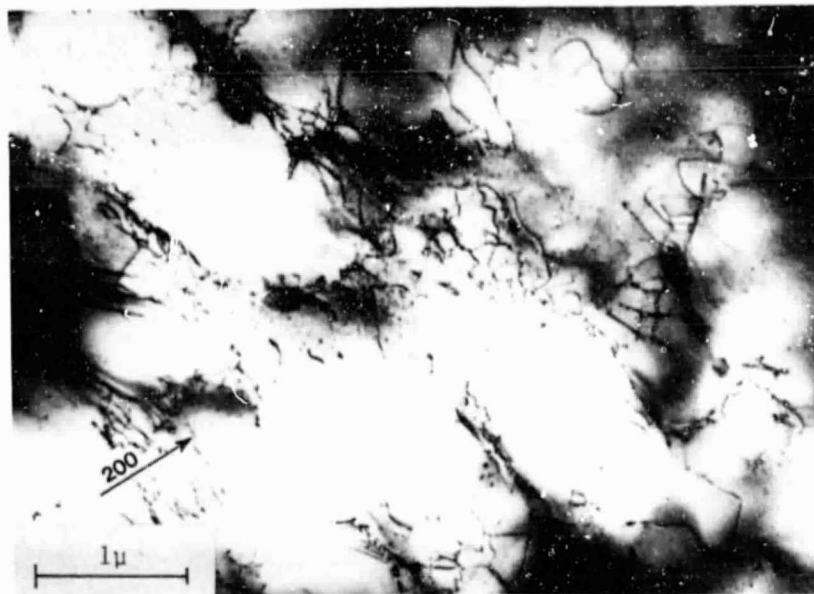
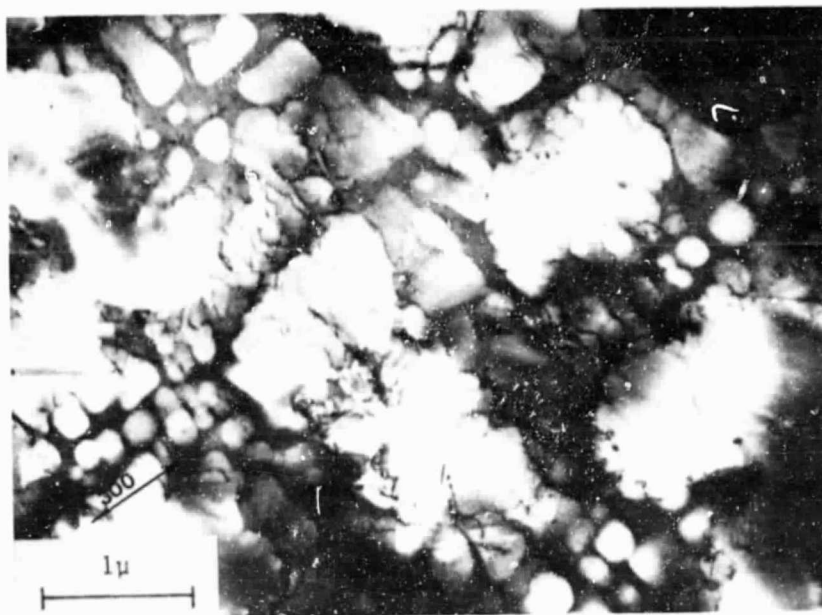
Fig. 5. TEM micrographs of the as-received microstructure. A) BF showing interfacial dislocations. B) Central Dark Field (CDF) showing the bi-modal γ' morphology and interfacial dislocations. (Not same area as 5A).

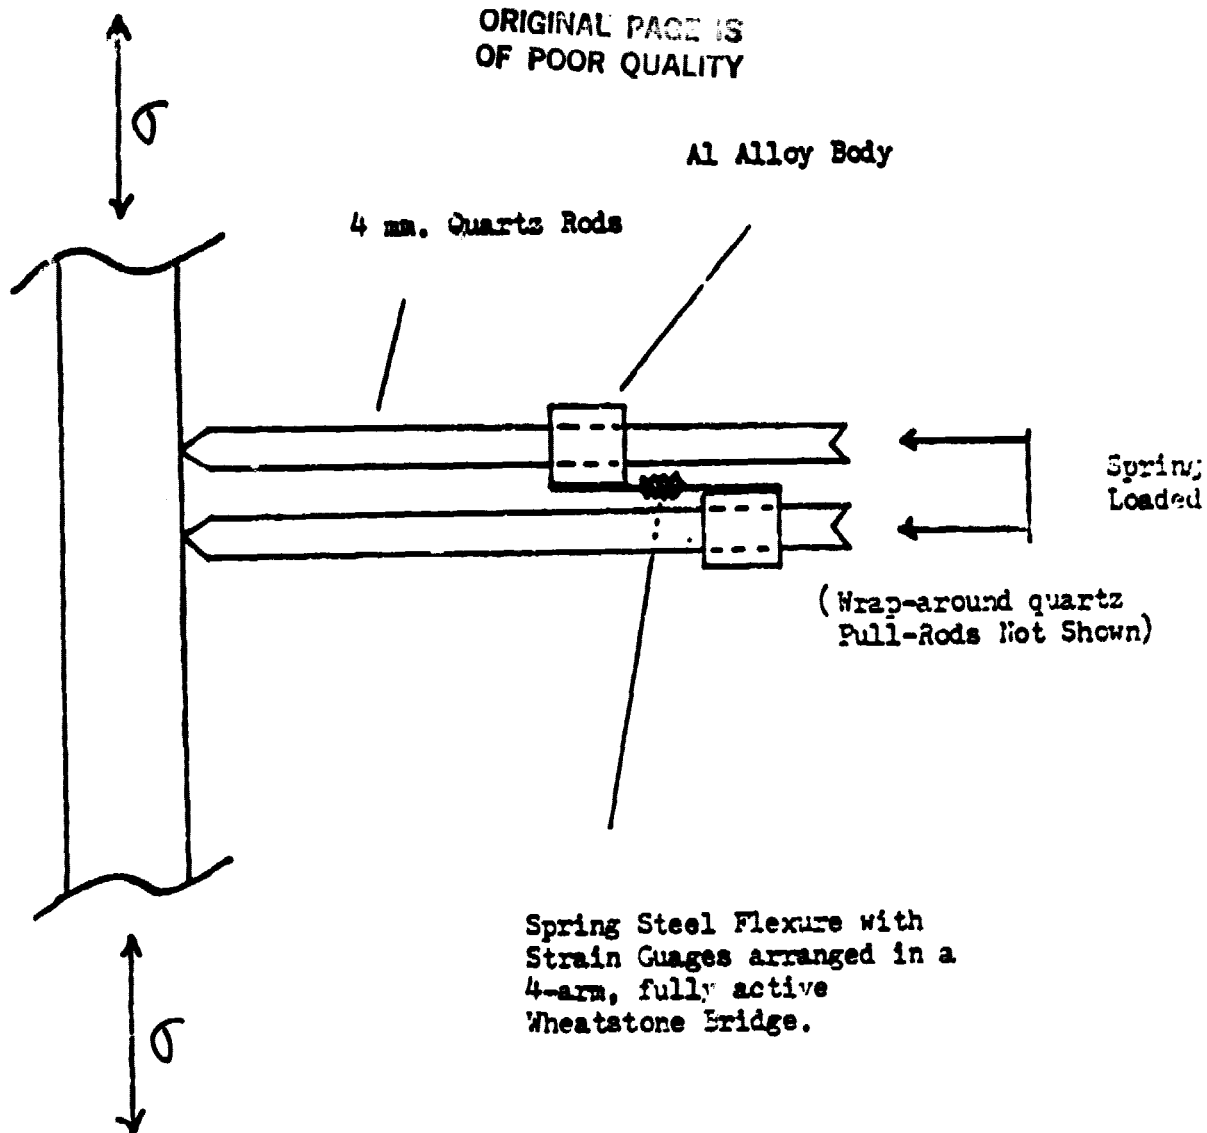
Fig. 6. Schematic of the High Temperature Extensometer

During testing, strain was measured by a spring loaded, quartz rod extensometer which is shown schematically in Figure 6. The extensometer was constructed by applying strain gages to the top and bottom of a spring steel flexure, which was attached by an aluminum frame to the quartz probes. The resulting four-arm, fully active wheatstone bridge was calibrated by a precision micrometer, and found to produce a linearly varying signal in the displacement range of interest. Strains and strain ranges were measured by a high resolution digital oscilloscope.

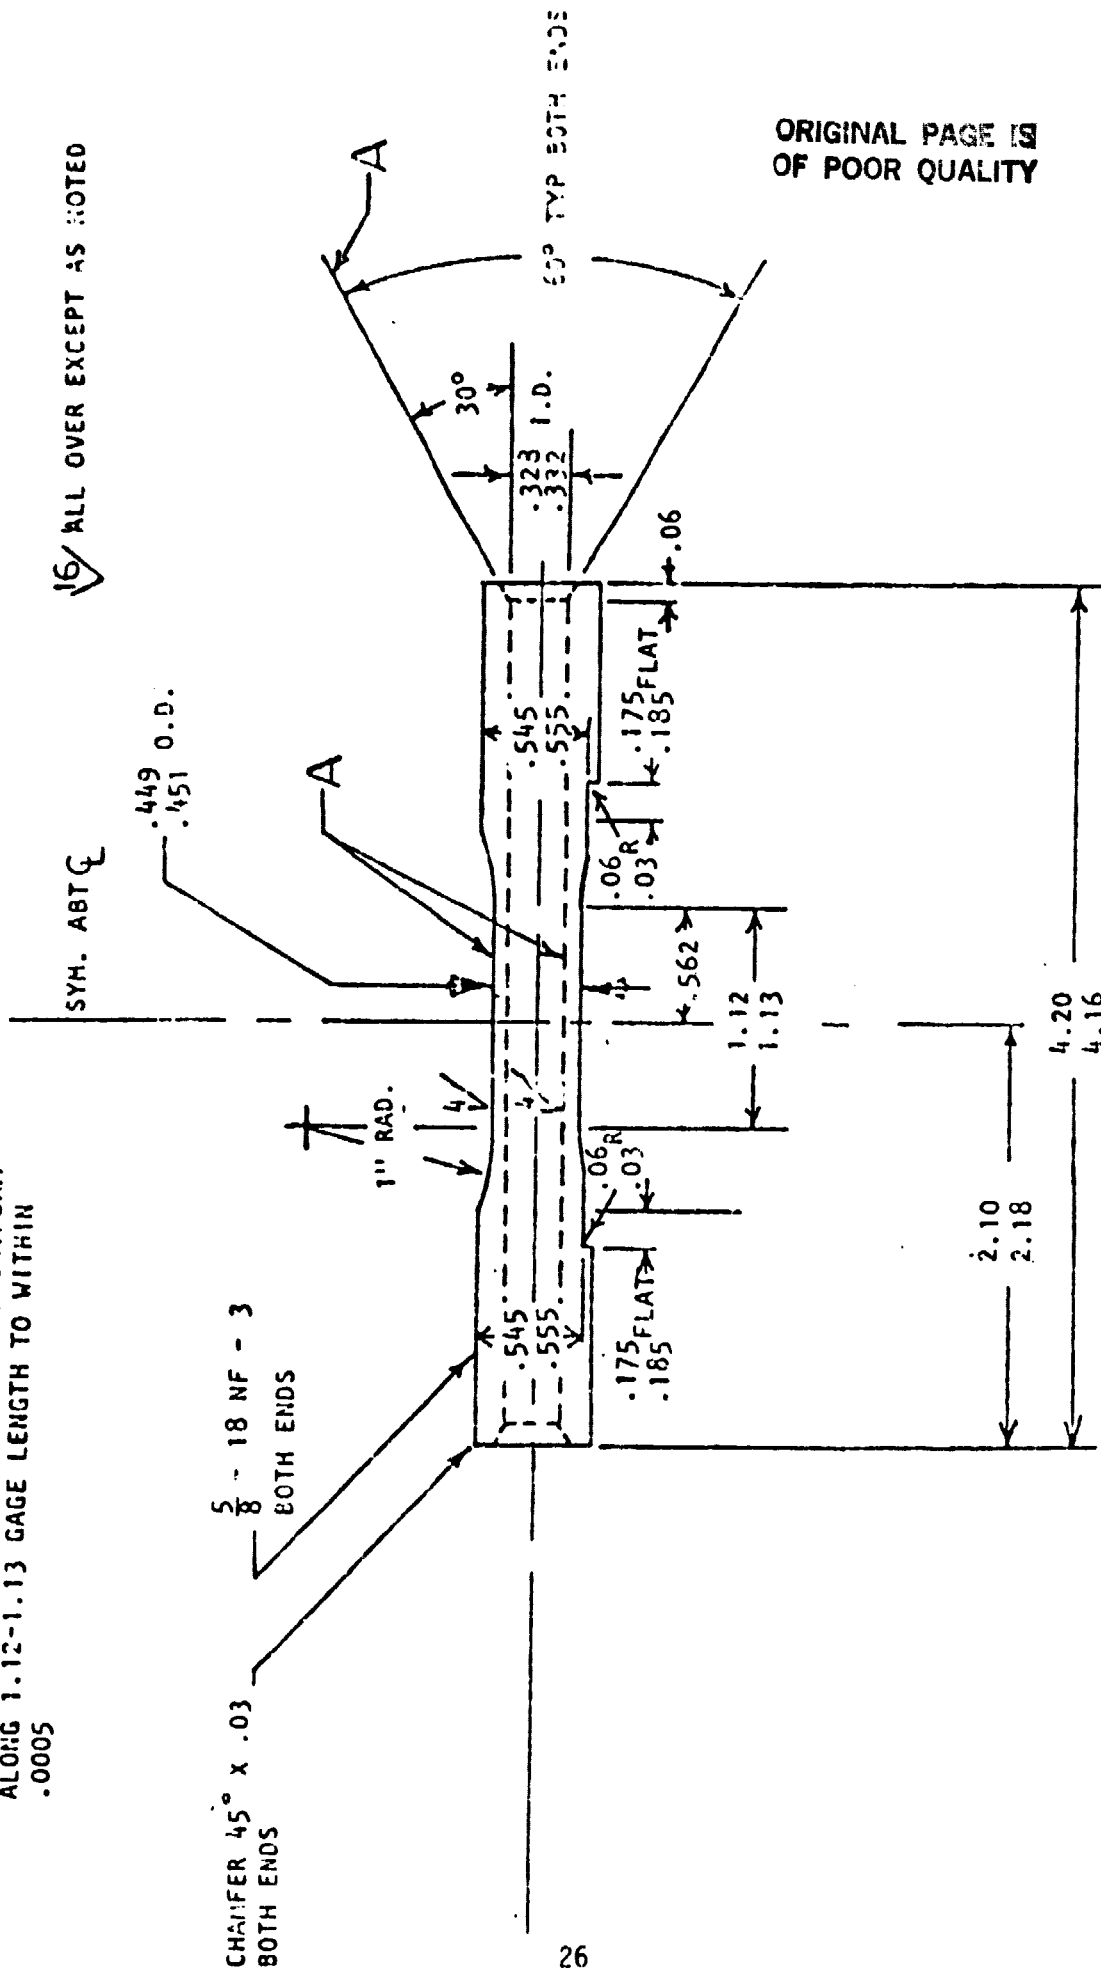
Fig. 7. Specimen Geometry

Twenty three high temperature low cycle fatigue tests were conducted, 14 at 760°C and 9 at 870°C . The specimens were hollow cylinders, as illustrated in Figure 7. Testing was conducted in the longitudinal strain

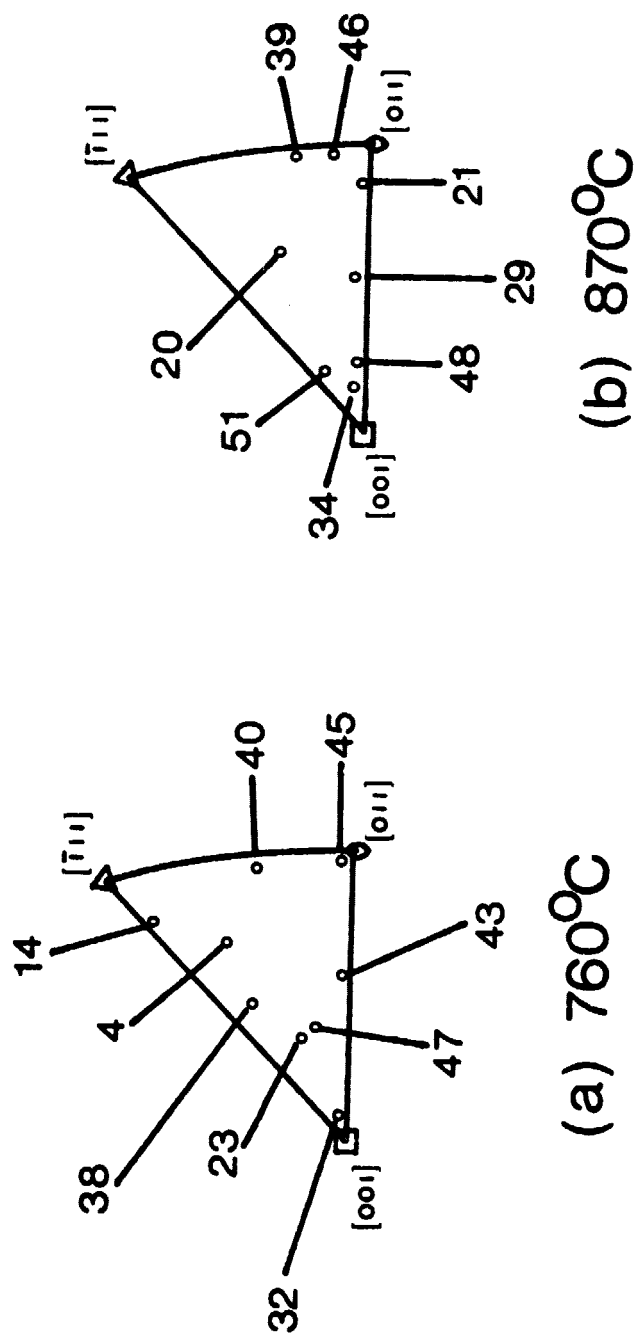
Fig. 8. Tensile axis orientations of the tested specimens (Constant $\Delta\epsilon_p$ only).

Specimen orientations are presented in Table I and Figure 8. Room temperature and elevated temperature elastic moduli are presented in Tables II, III. The anisotropy is clearly evident, as the room temperature modulus of elasticity varied from 90 GPa to 220 GPa with different orientations.

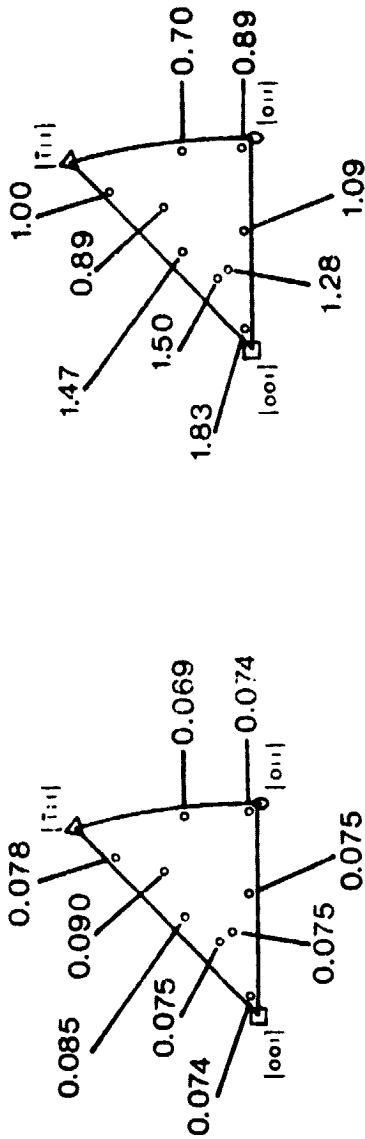
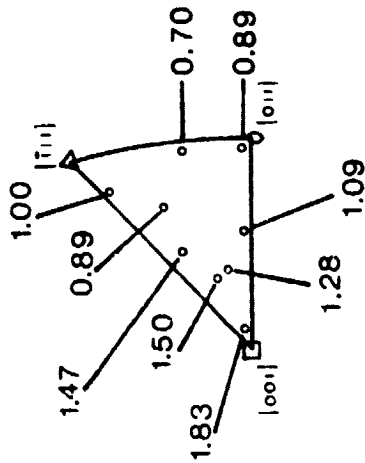
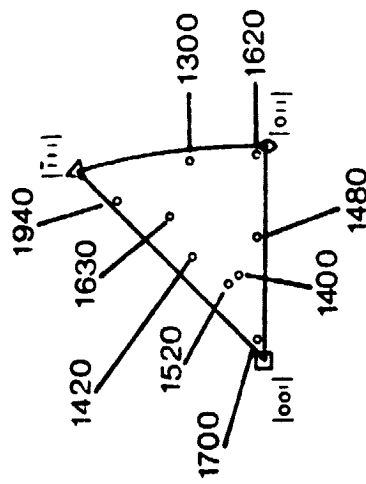
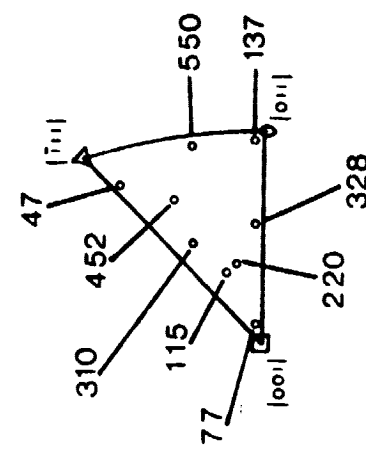
Fig. 9. Experimental data from the 760°C, constant plastic strainrate tests.

Nine tests were conducted at a nominal plastic strain range ($\Delta\epsilon_p$) of 0.1%, and four tests were conducted at higher plastic strain ranges. Experimental parameters are plotted vs. orientation in Figure 9.

As these figures illustrate, when the $\Delta\epsilon_p$ was held constant but the tensile axis orientation was changed, other test parameters (total strain range ($\Delta\epsilon_t$), stress range ($\Delta\sigma$), and most importantly cyclic life (N_f)) varied significantly. Several trends can be clearly identified:

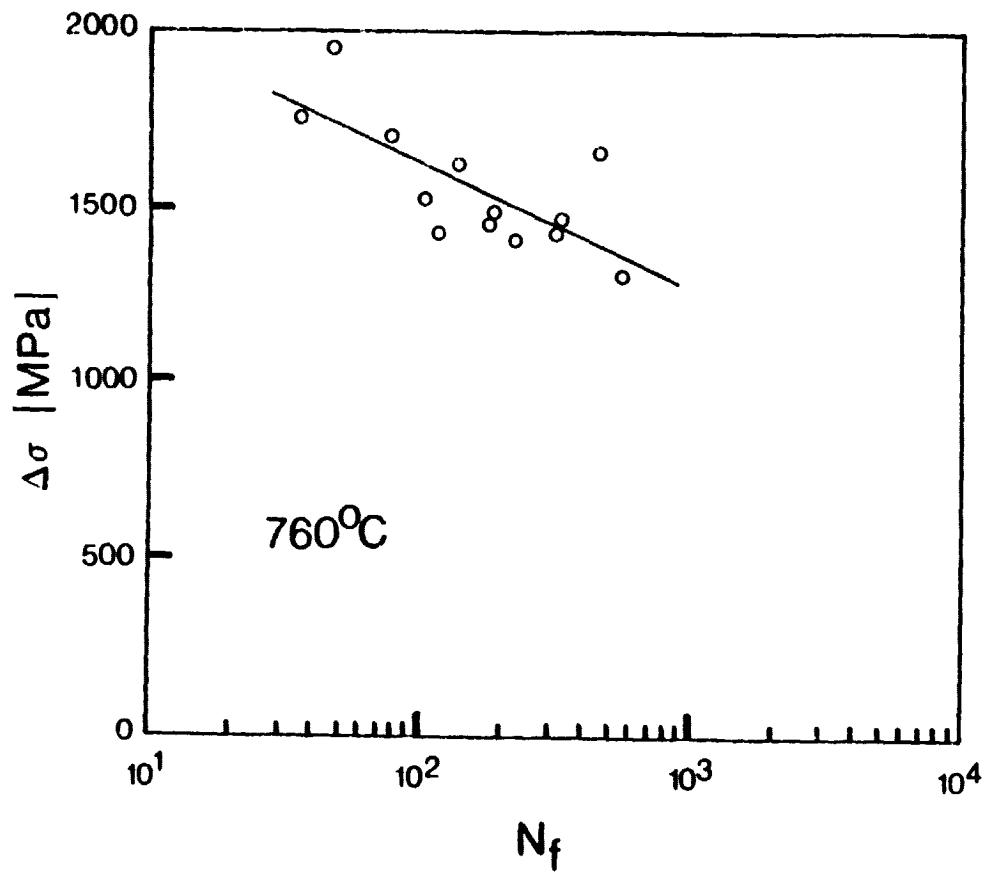
Fig. 10. $\Delta\sigma$ vs. N_f at 760°C .

A Coffin-Manson plot was attempted, but N_f varied by more than a factor of 10 for the same nominal $\Delta\epsilon_p$. A plot of $\Delta\epsilon_t$ vs. N_f proved fruitless because of the differences in elastic moduli. The most successful relationship was found to exist between $\Delta\sigma$ and N_f , where most of the data fell within a factor of 2. (Figure 10). This is the case because the stress range is intimately related to orientation, strain hardening, and ductility, as explained above.

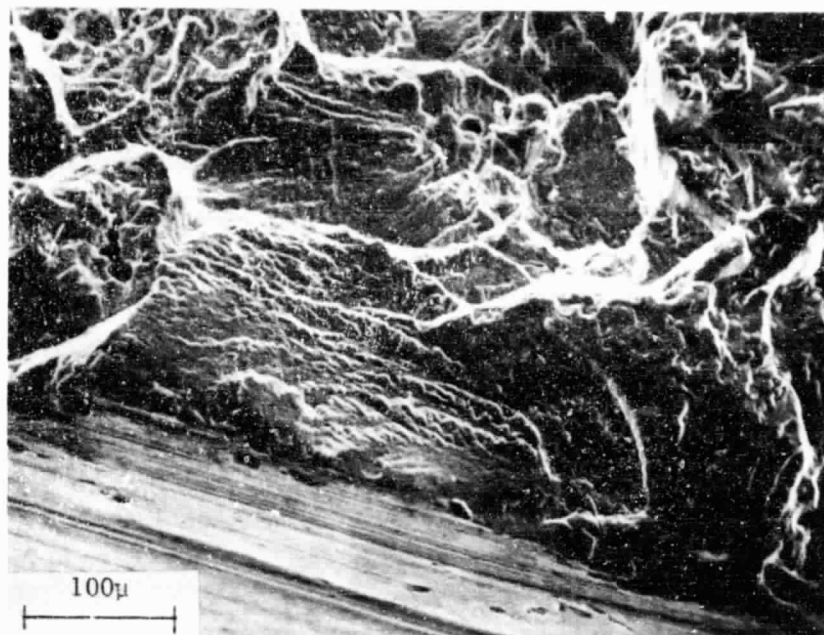
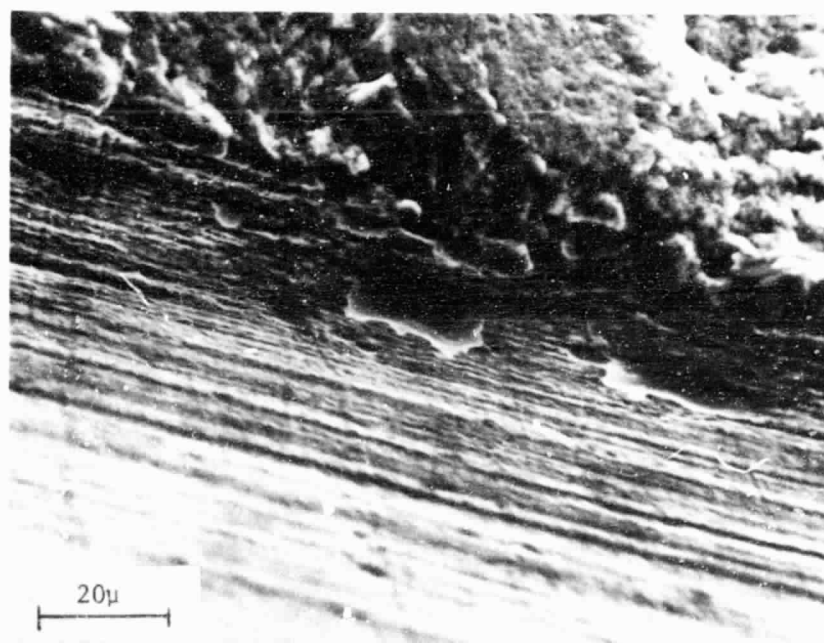
Fig. 11. Increasing magnification SEM fractographs showing microporosity at the crack initiation site. Specimen PF43. Note slip traces on the specimen surface.

One orientation effect was observed optically: single slip orientations and orientations near (011) had obvious slip traces on the specimen surface. (Figures 17, 11). Orientations near (001) and (111) showed no evidence of these slip traces. It was determined that the slip traces corresponded to the primary octahedral shear planes. The fatigue cracks always initiated at the apices of the slip trace ellipses, which corresponded to the region where the normal stress, which opens the crack and facilitates early

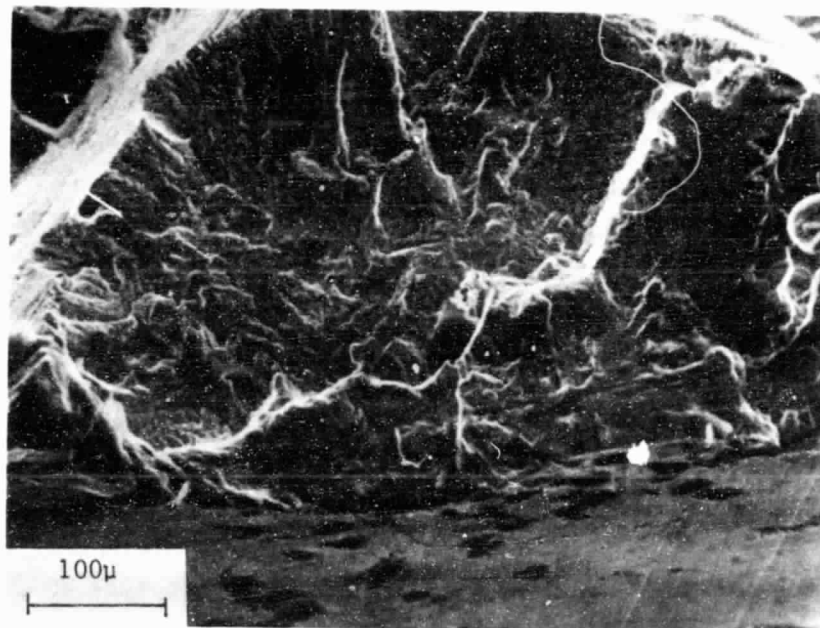
Fig. 12. SEM fractograph showing a high concentration of micropores at the crack initiation site. Specimen FF38.

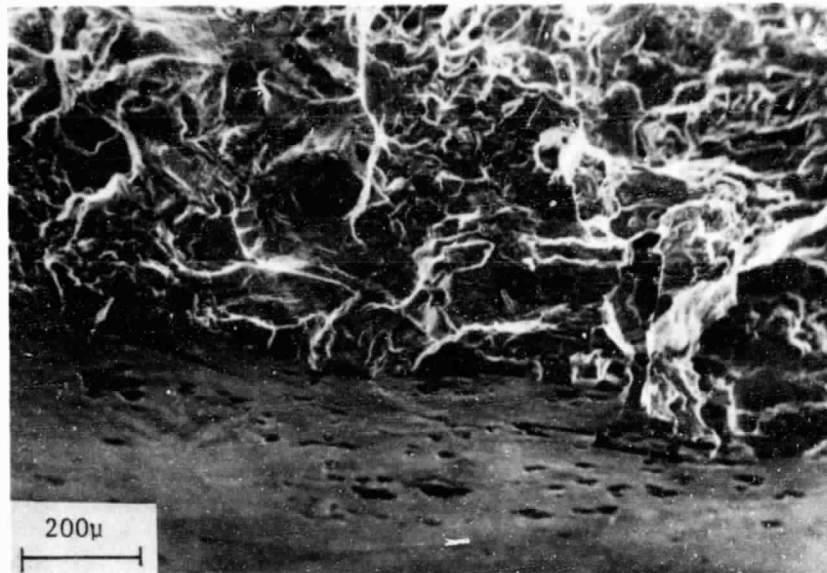
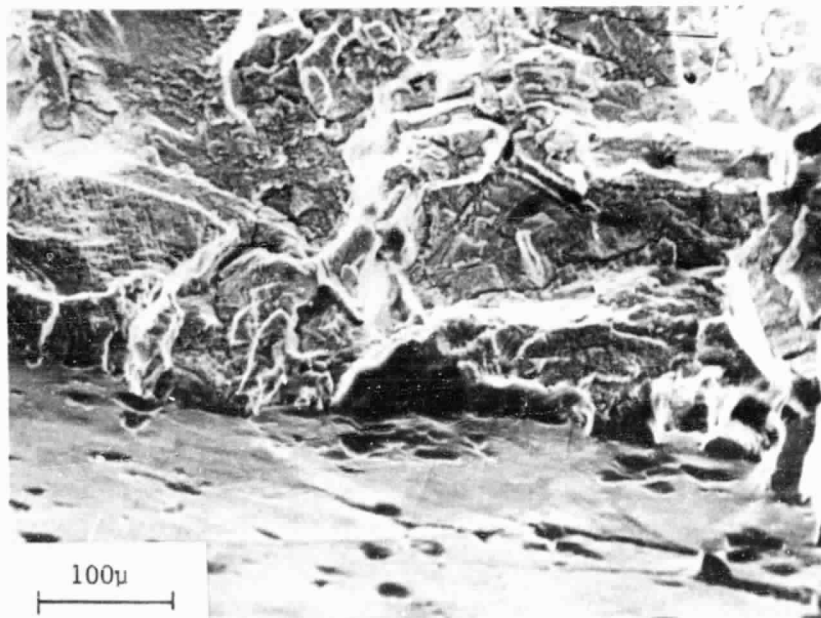
Fig. 13. Increasing magnification SEM fractographs showing micropores at the crack initiation site. Specimen FF23.

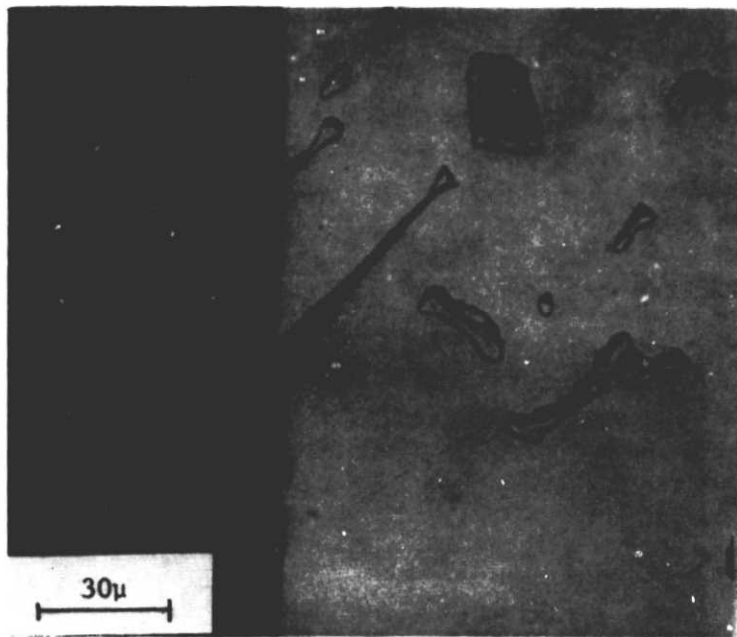
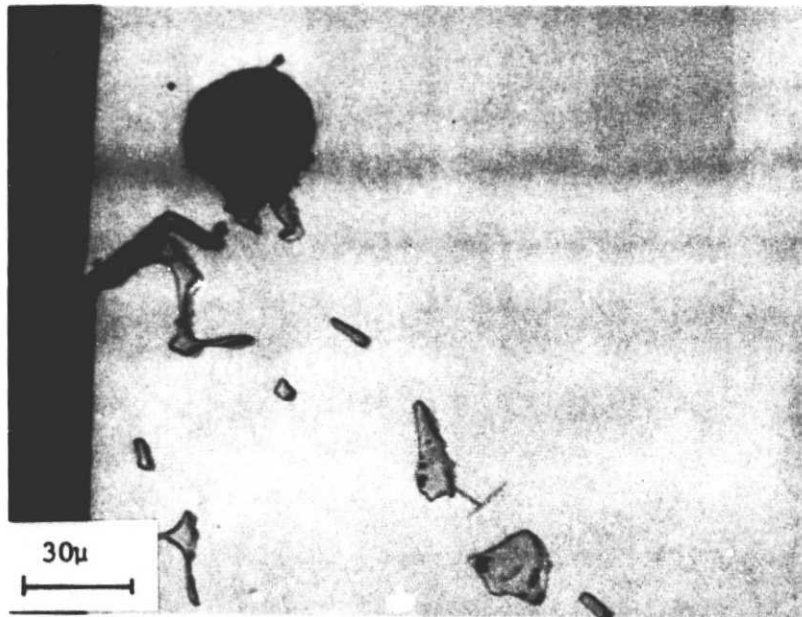
Fig. 14. Photomicrographs showing possible Stage I initiation at carbides. Specimen FF23.

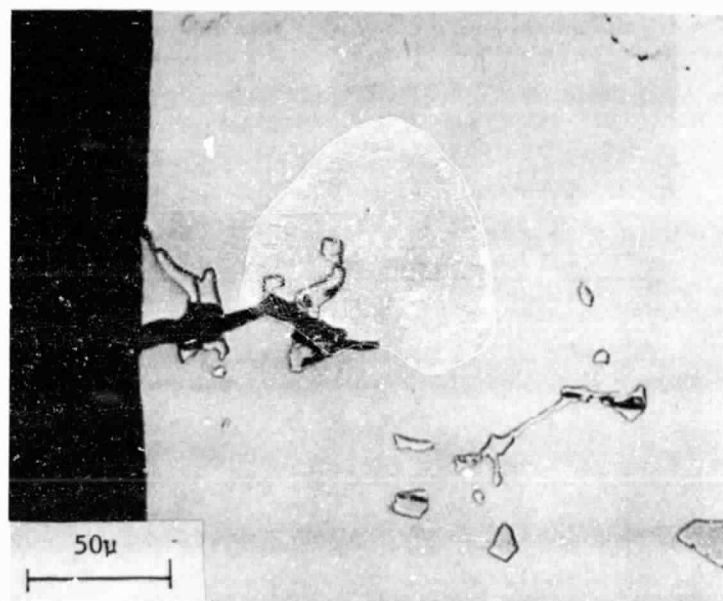
Fig. 15. Photomicrograph showing possible initiation at "cracked" carbides. Specimen FF43.

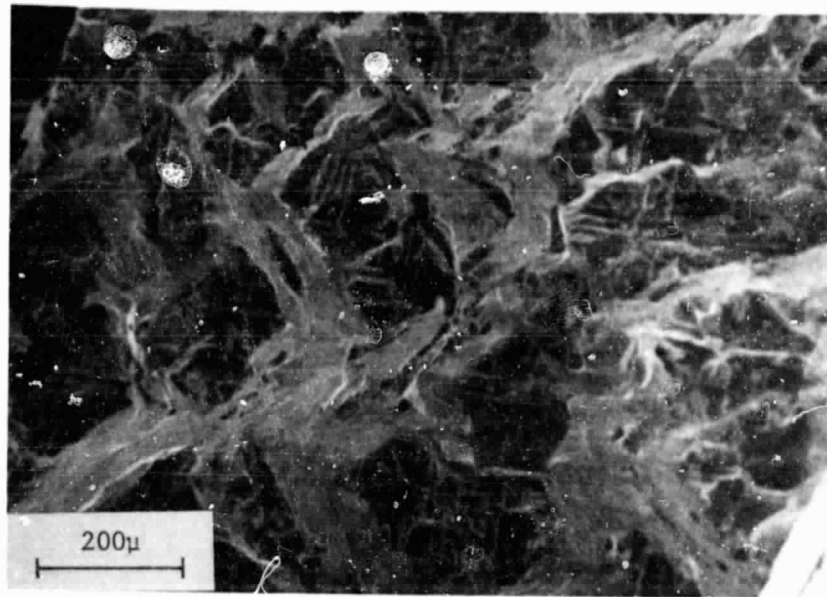
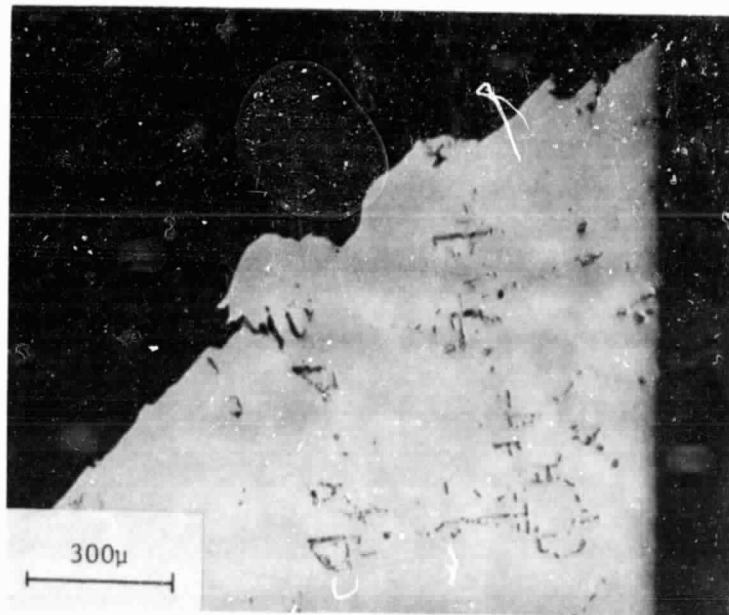
Fig. 16. Final tensile failure mode. A) SEM fractograph showing the dual nature of the crack. Smooth, lighter areas correspond to the octahedral shear planes, while darker, rough areas correspond to the dendrite boundaries (Note carbide pattern). B) Photomicrograph of the same specimen showing the shear plane fracture at about 45° to the tensile axis. Specimen FF23.

It was established through SEM fractography and optical metallography that the mechanisms of crack initiation and propagation were essentially independent of orientation. Every specimen showed strong evidence of multiple crack initiation at surface connected and sub-surface micropores. (Figures 11-13). Some evidence of Stage I crack initiation involving carbides (Figure 14) and initiation due to "cracked" carbides (Figure 15) was found metallographically, but the major "crack initiator" appeared to be microporosity. Crack propagation was observed to be in the Stage II mode (perpendicular to the tensile axis). Final tensile failure occurred by a combination of crystallographic cracking along shear planes and interdendritic tearing. (Figure 16).

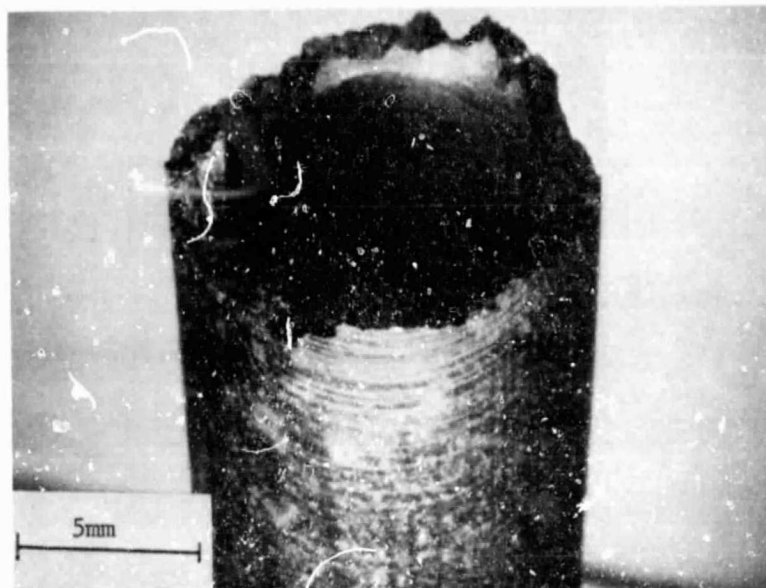
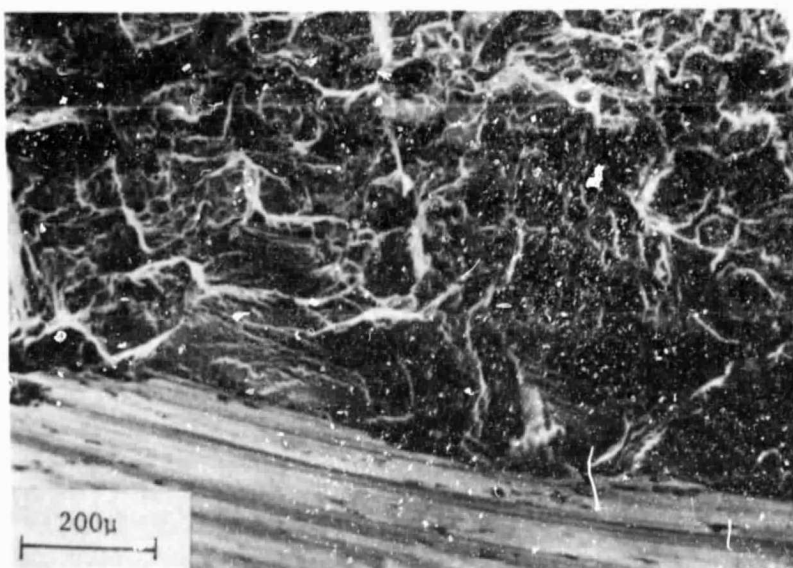
Fig. 17. Slip traces on specimen surface due to shear on a single octahedral p'ane. A) Photomacrograph, Specimen FF43. B) SEM fractograph, same specimen.

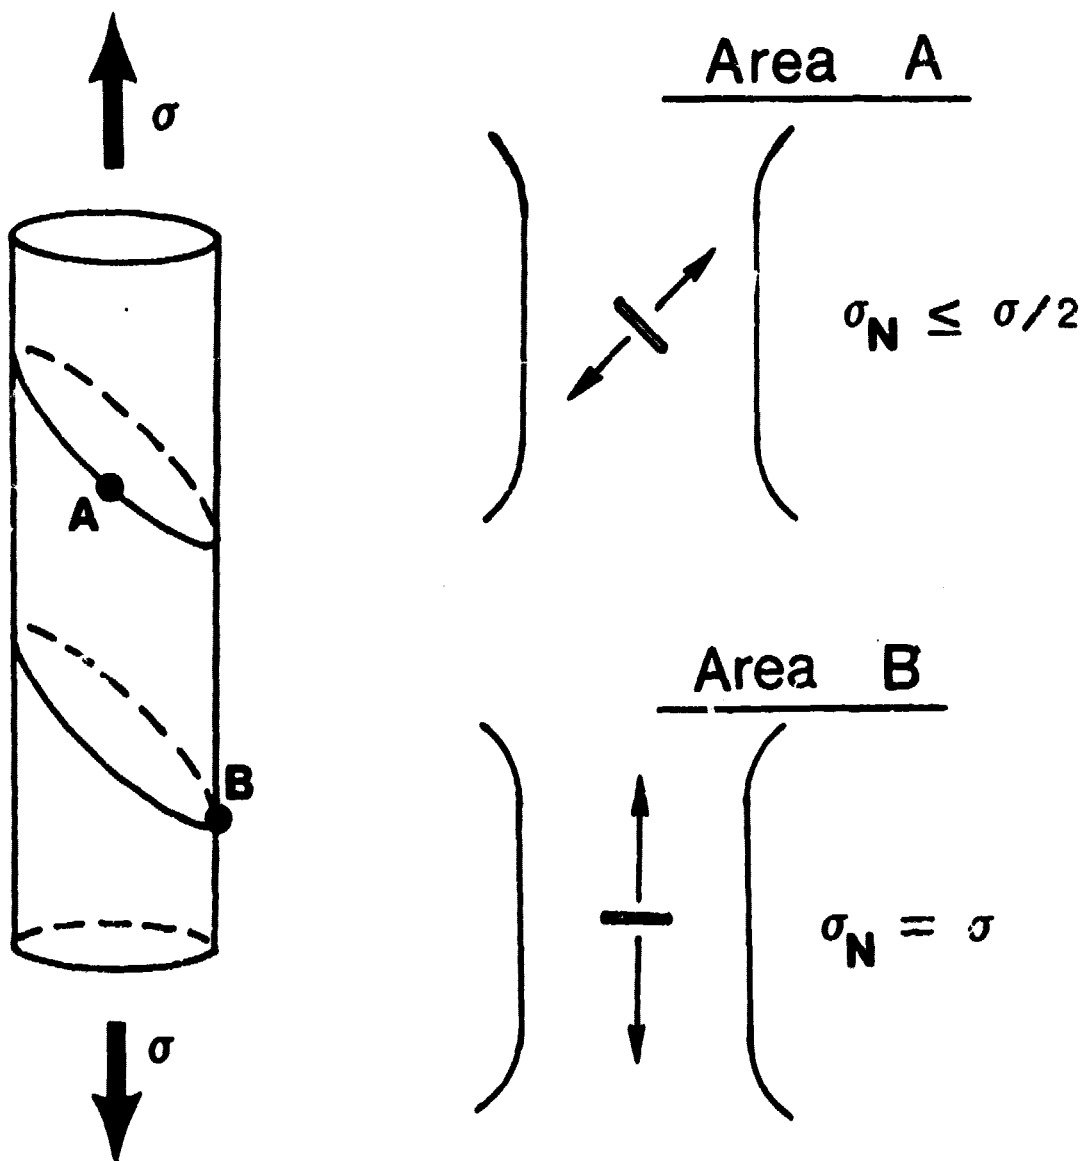
Fig. 18. Stress diagram illustrating why the fatigue crack initiation is at a consistent site on the specimen surface (Area B) in single slip orientations at 760°C.

propagation, was at a maximum. (Figure 18).

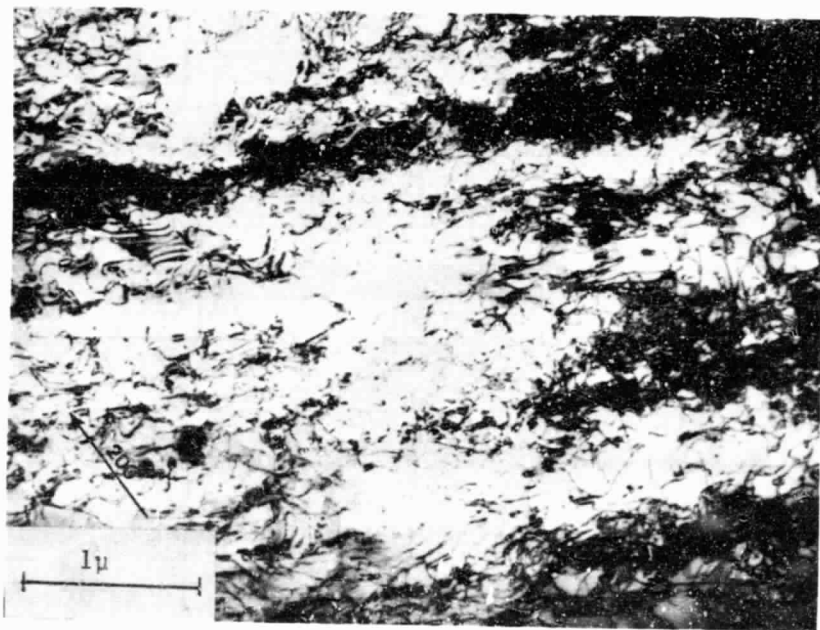
Fig. 19. BF TEM micrograph of deformation microstructure in a single slip orientation at 760°C. A) Specimen FF23. Note parallel dislocation bands.

Over half of the tested specimens were evaluated by Transmission Electron Microscopy. It was confirmed that the majority of the dislocations present in the single slip orientations did lie on the primary octahedral shear plane, and many of these dislocations were present in a parallel array of dislocation bands. (Figure 19). Most of these dislocations were of the type $a/2[\bar{1}01](111)$. (Details of the dislocation analysis technique used to determine the burgers vector and the slip plane are presented in Appendix A). Although there were some dislocations present in the γ' , the majority of the dislocations appeared to be in the matrix or at the γ/γ' interface. Several dislocations of the type $a/2[\bar{1}01](010)$ (Cube planes) were observed in the γ' , but they did not appear to be very numerous. Also, they did not appear to be shearing the γ' . More work is being done to confirm these observations.

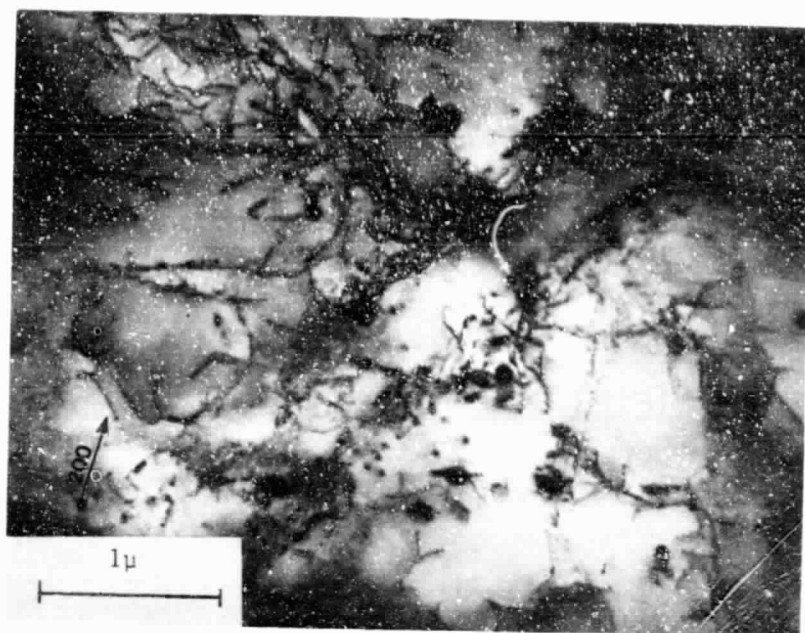
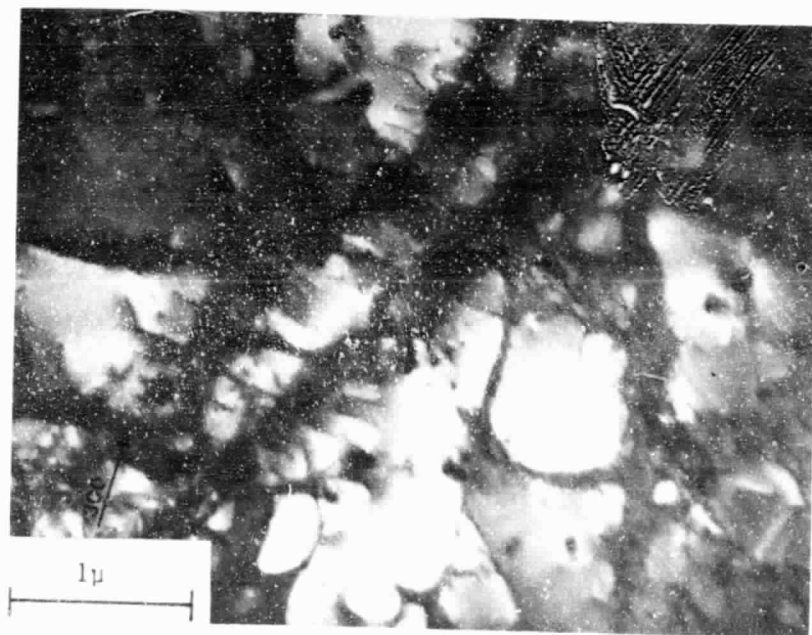
Fig. 20.

TEM micrographs of slip bands in a multiple slip orientation at 760°C. Specimen 27, which was interrupted after 5 cycles. A) BF showing two parallel slip bands, and a 3rd (at left) intersecting at an angle. B) CDF of the same area. Note some dislocations in the γ' . Due to tilt constraints, the bands could not be brought into the "edge-on" condition to determine whether or not the γ' was being sheared.

In the multiple slip orientations, slip occurred on more than one octahedral plane, as predicted by Schmid's Law. Intersecting slip bands were observed. (Figures 20, 21).

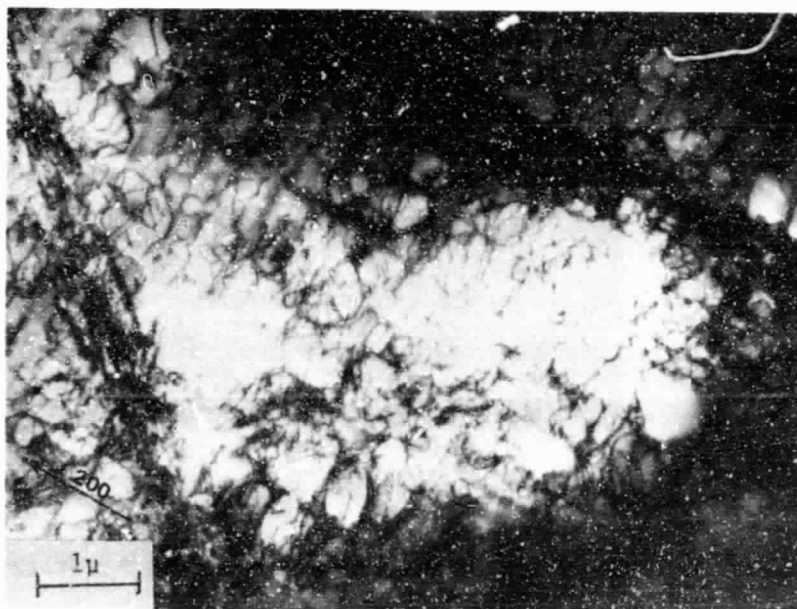
Fig. 21. BF TEM micrographs of specimen FF27 (Figure 23) showing three intersecting slip bands, and a high concentration of dislocations that were not in a band structure.

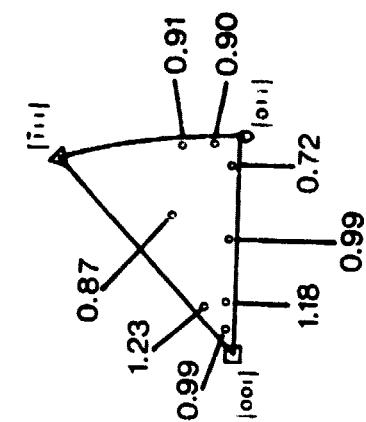
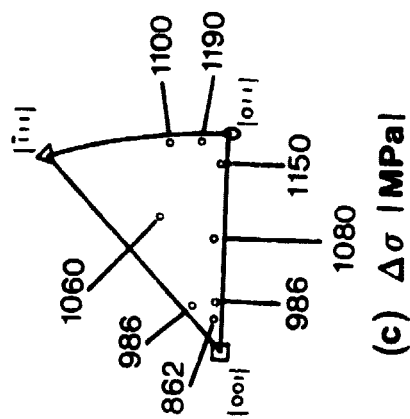
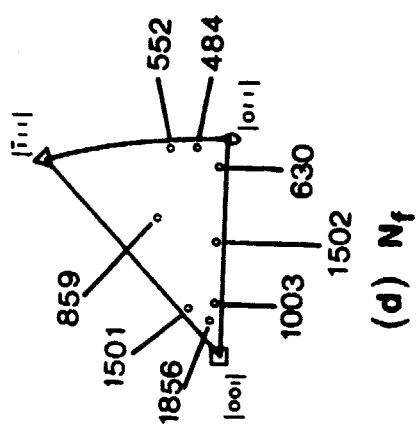
Fig. 22. 870°C experimental data.

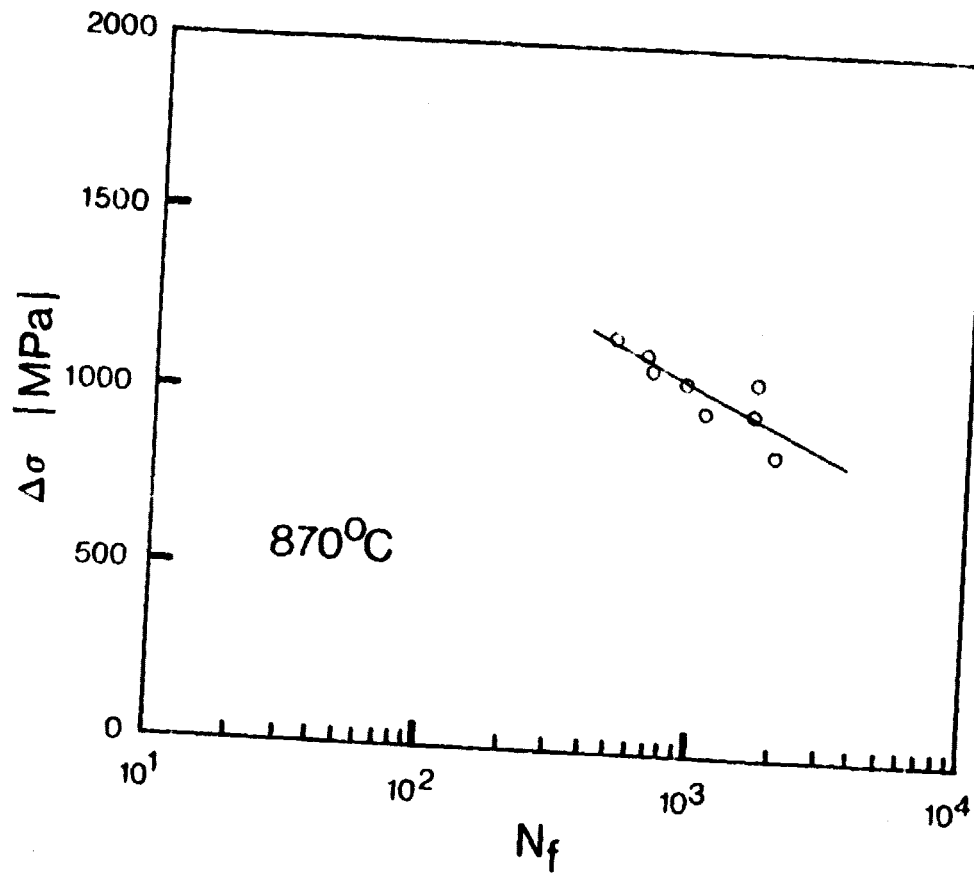
Fig. 23. $\Delta\sigma$ vs. N_f at 870°C.

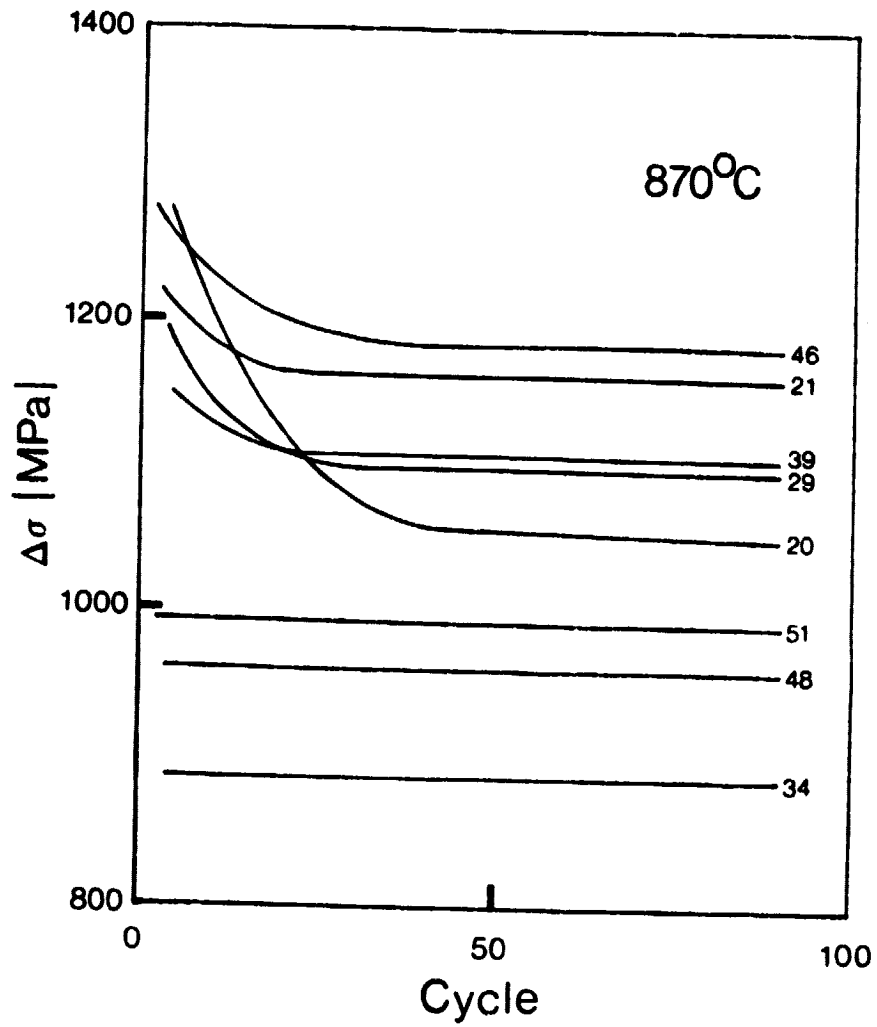
Fig. 24. Initial cyclic stress response at 870°C. The bottom three orientations are near (001).
